March 31, 2016 Dico Site Visit

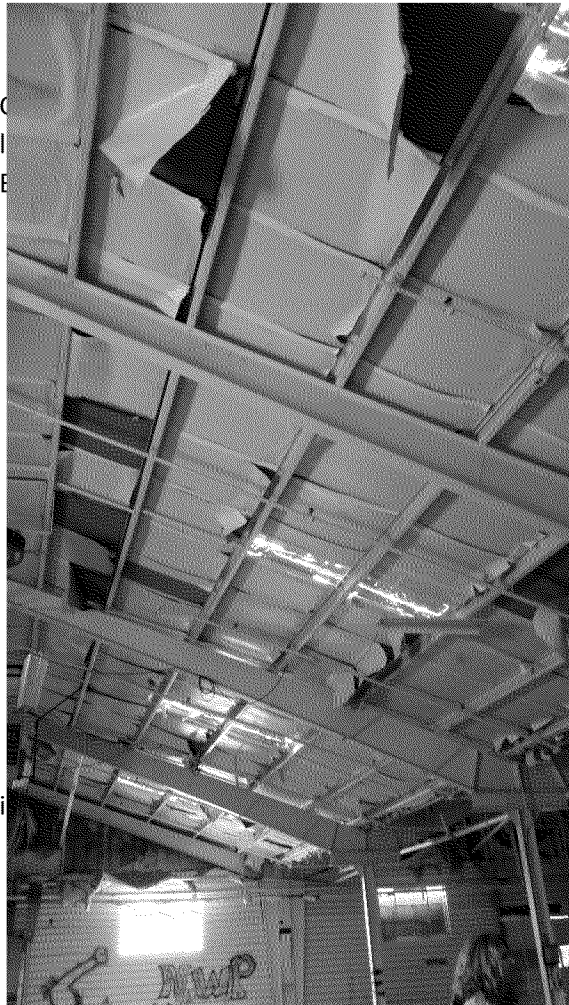
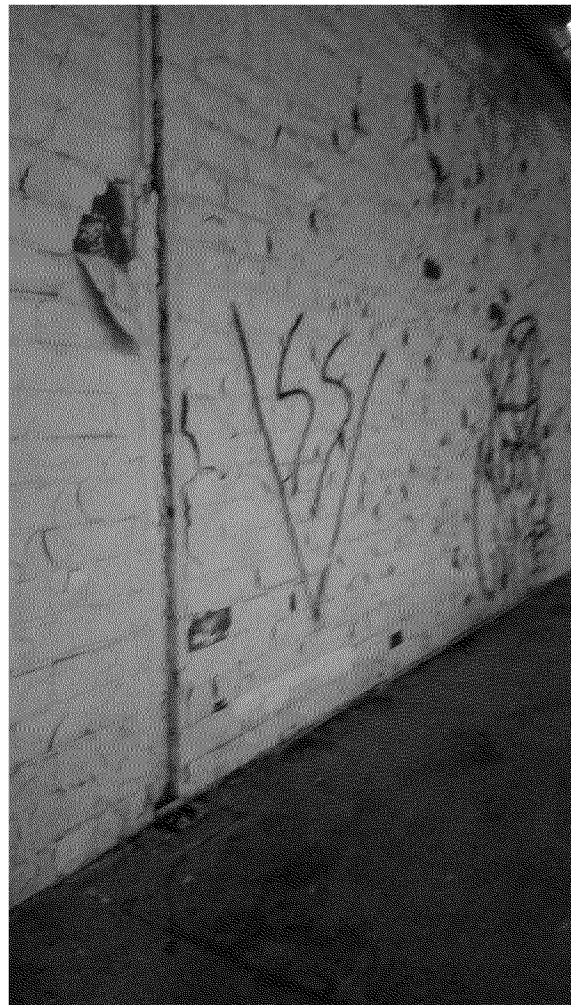
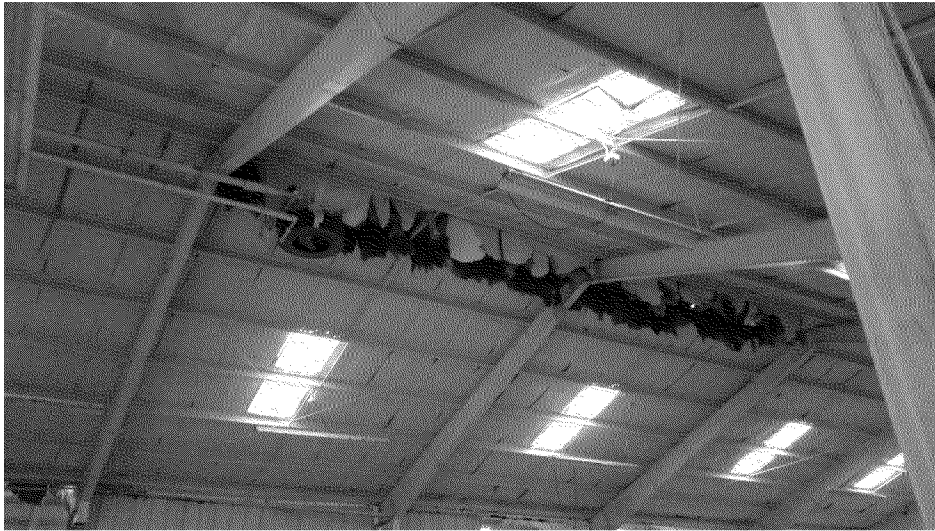
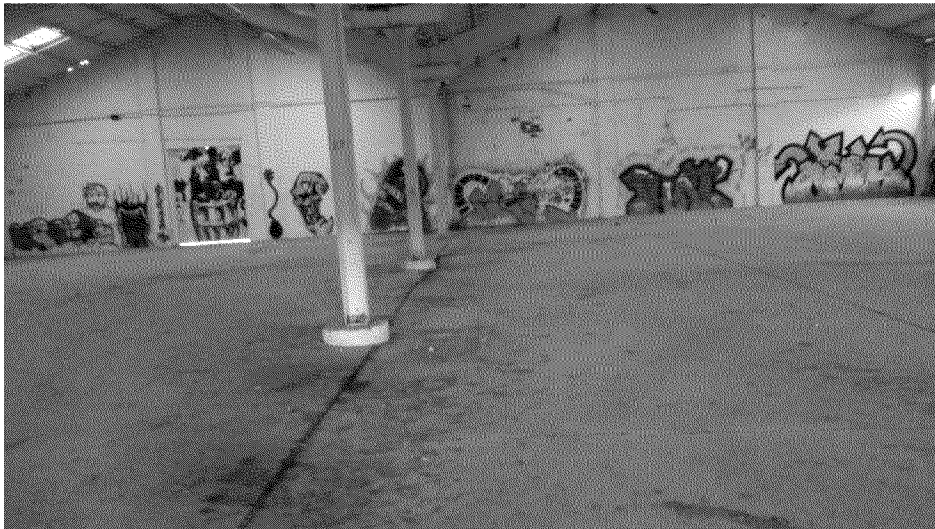
In Building 2, a lot of the paint was chipping off of the walls (as seen with the pictures below). Ceiling sealing material was also falling. Windows were broken, though several of them were covered with wood from the outside.

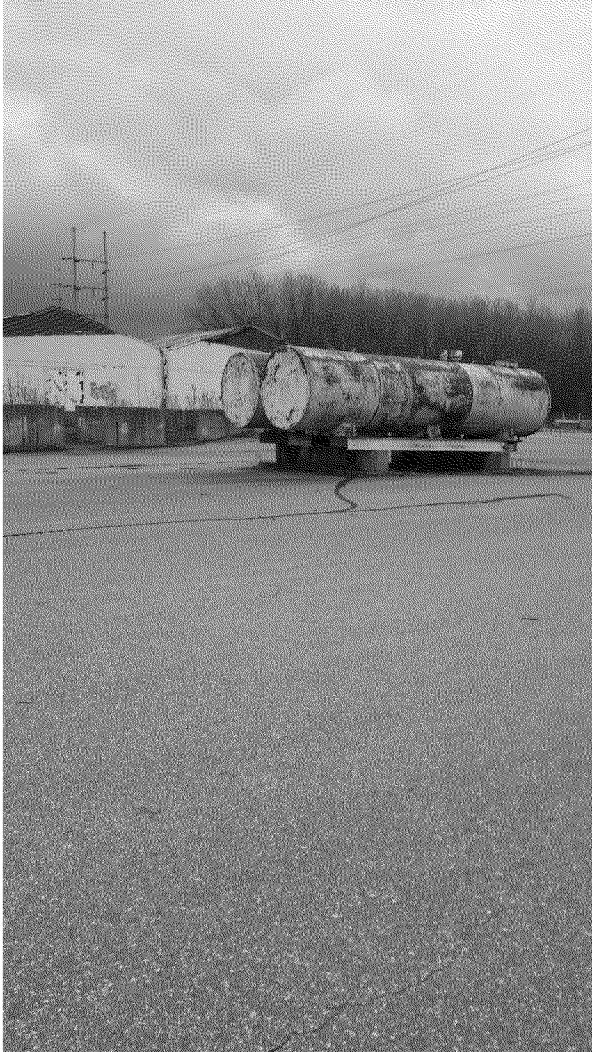
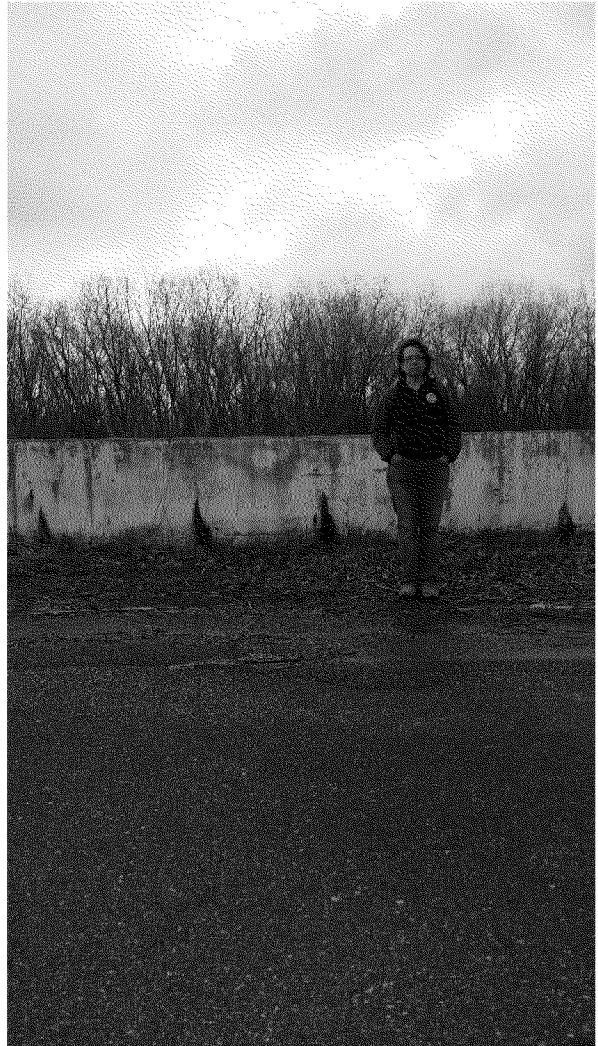
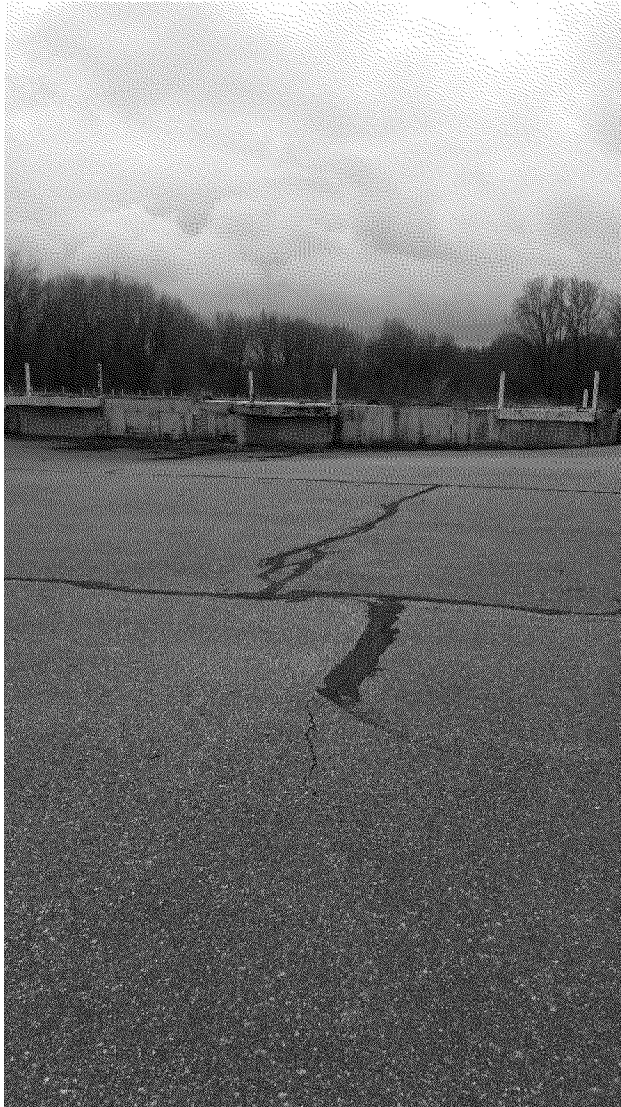
The foundation of Buildings 4 and 5 extends above the ground surface approximately 1 to 3 feet depending on the location. It is unknown if it is a solid structure or if it is a concrete frame with a concrete floor top. This could pose difficulties with concrete coring if the foundation is solid.

The concrete was relatively intact with minimal vegetation growth in previously patched seams.

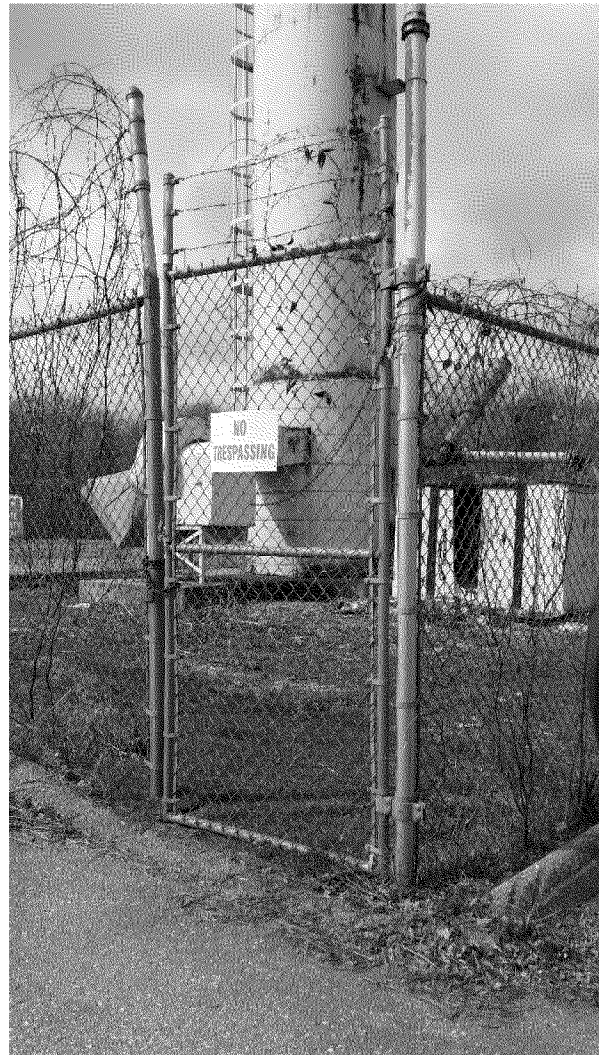
The treatment area was fenced, though Brian mentioned that at one time a homeless man was living in the attached shed. The area is completely surrounded by a chain link fence with barbed wire on top.

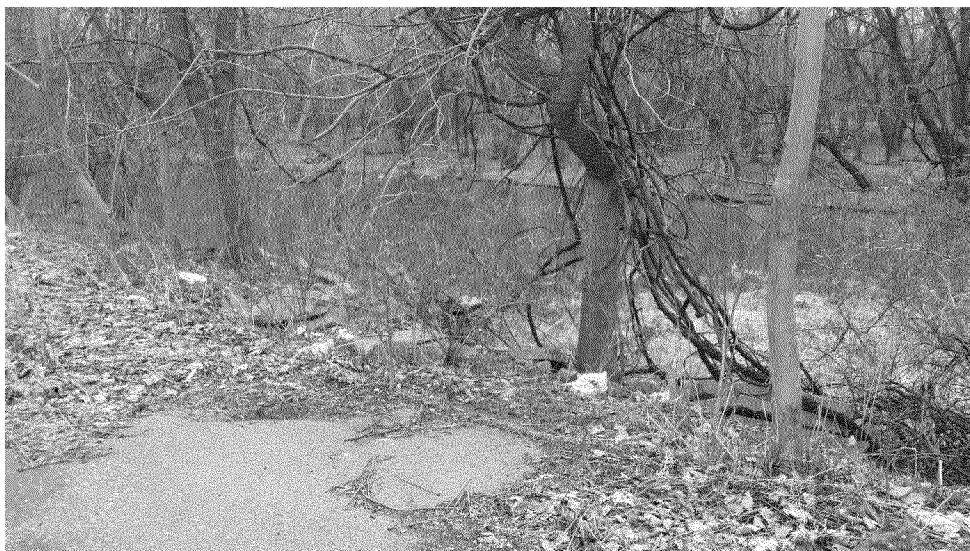
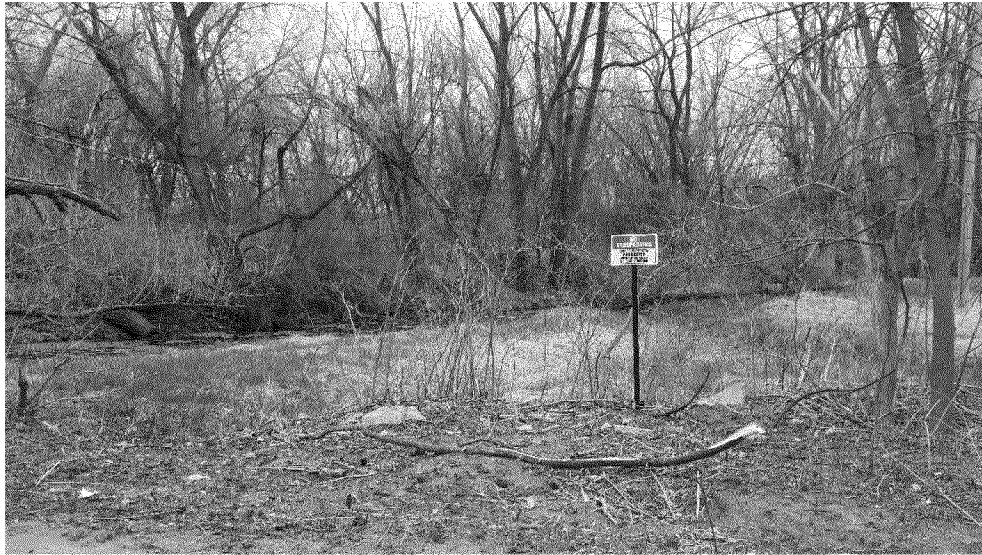
The South Pond Area (SPA) is located outside of the fence. There is a lot of trash around the area. No trespassing signs are displayed approximately every 50 feet. A security guard was on site, picking up trash. The SPA is much larger than it appears on the map.
